NASA Technical Memorandum 86347

**DIRECT-STRIKE LIGHTNING PHOTOGRAPHS,
SWEPT-FLASH ATTACHMENT PATTERNS,
AND FLIGHT CONDITIONS FOR
STORM HAZARDS '82**

**Klaus P. Zaepfel,
Bruce D. Fisher,
and Merle S. Ott**

February 1985

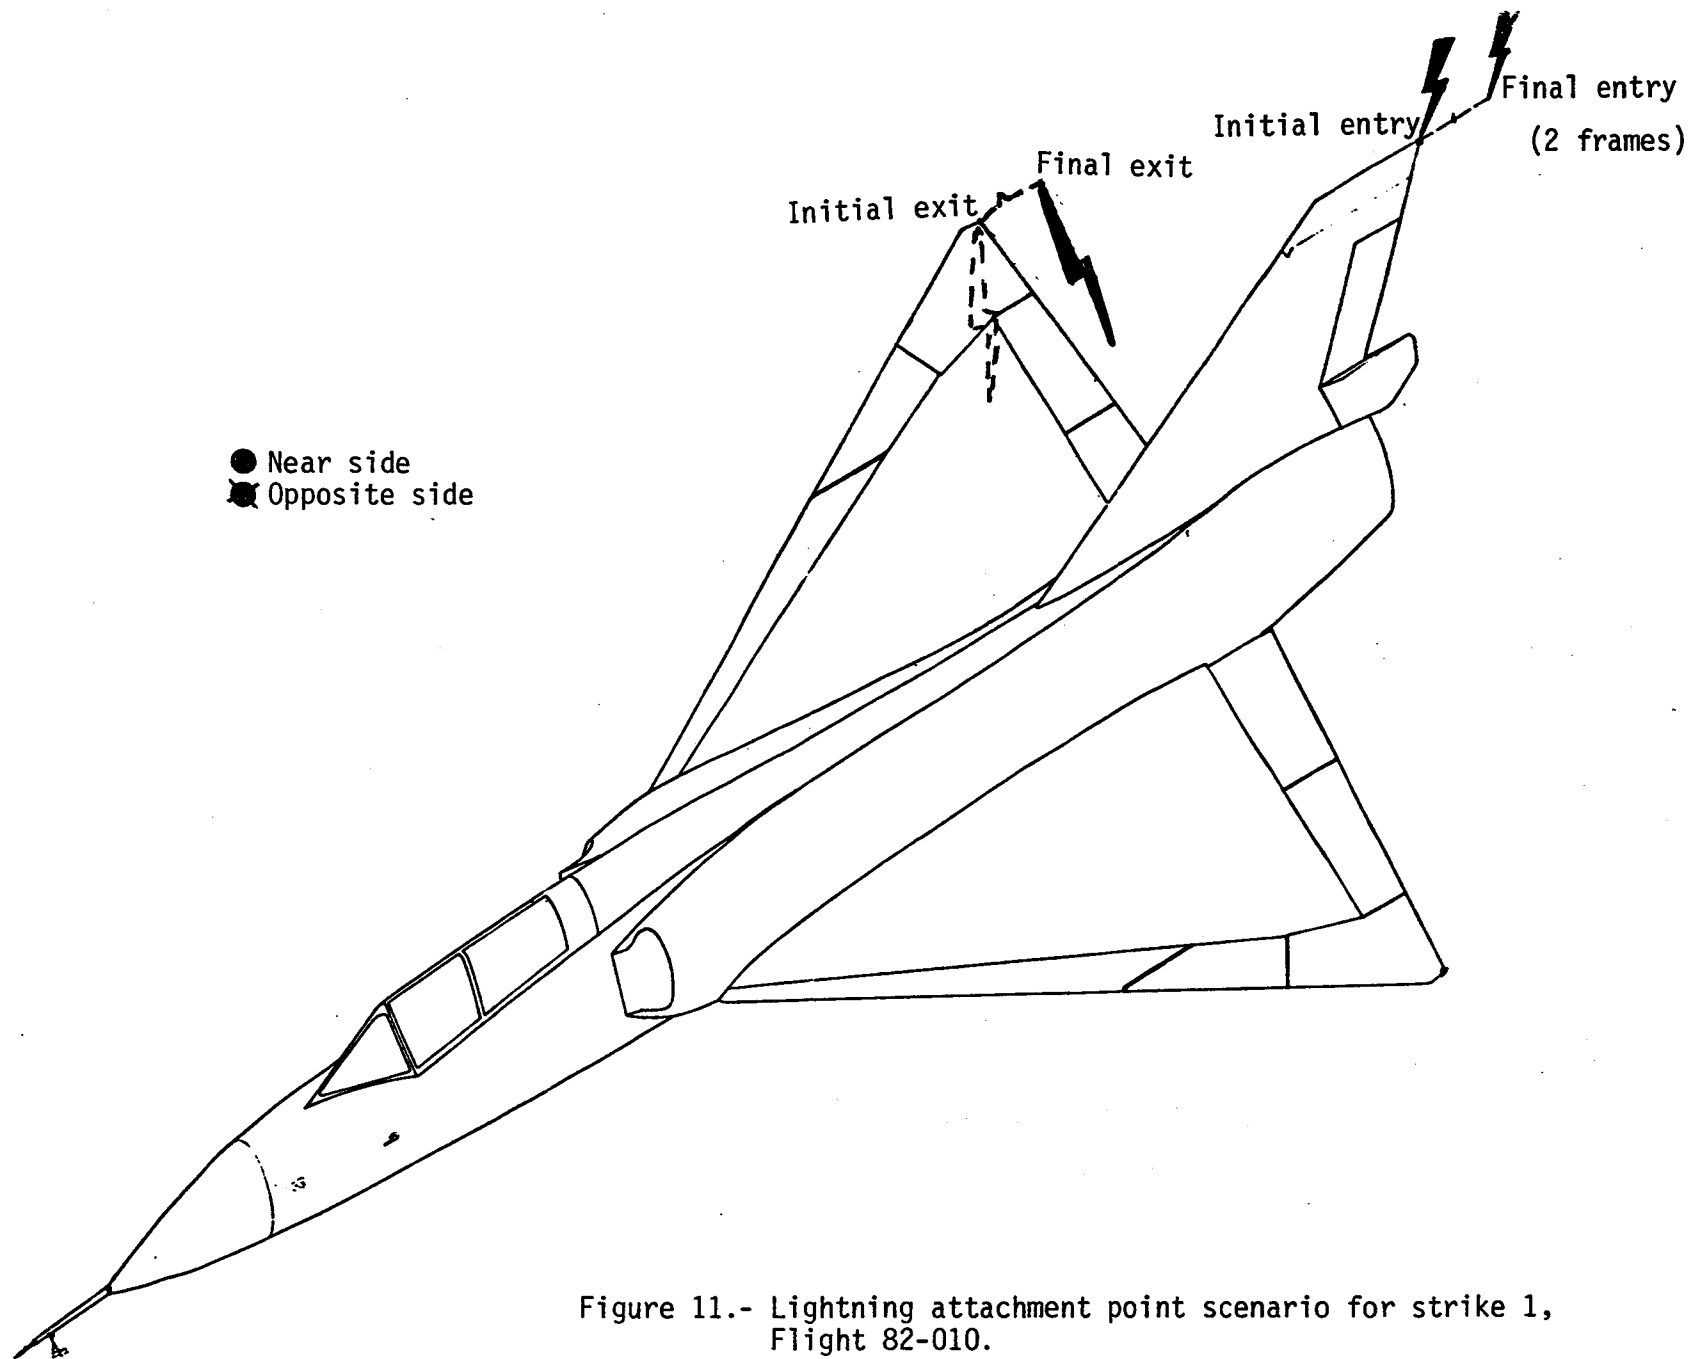
Figure 11.- Lightning attachment point scenario for strike 1, Flight 82-010.

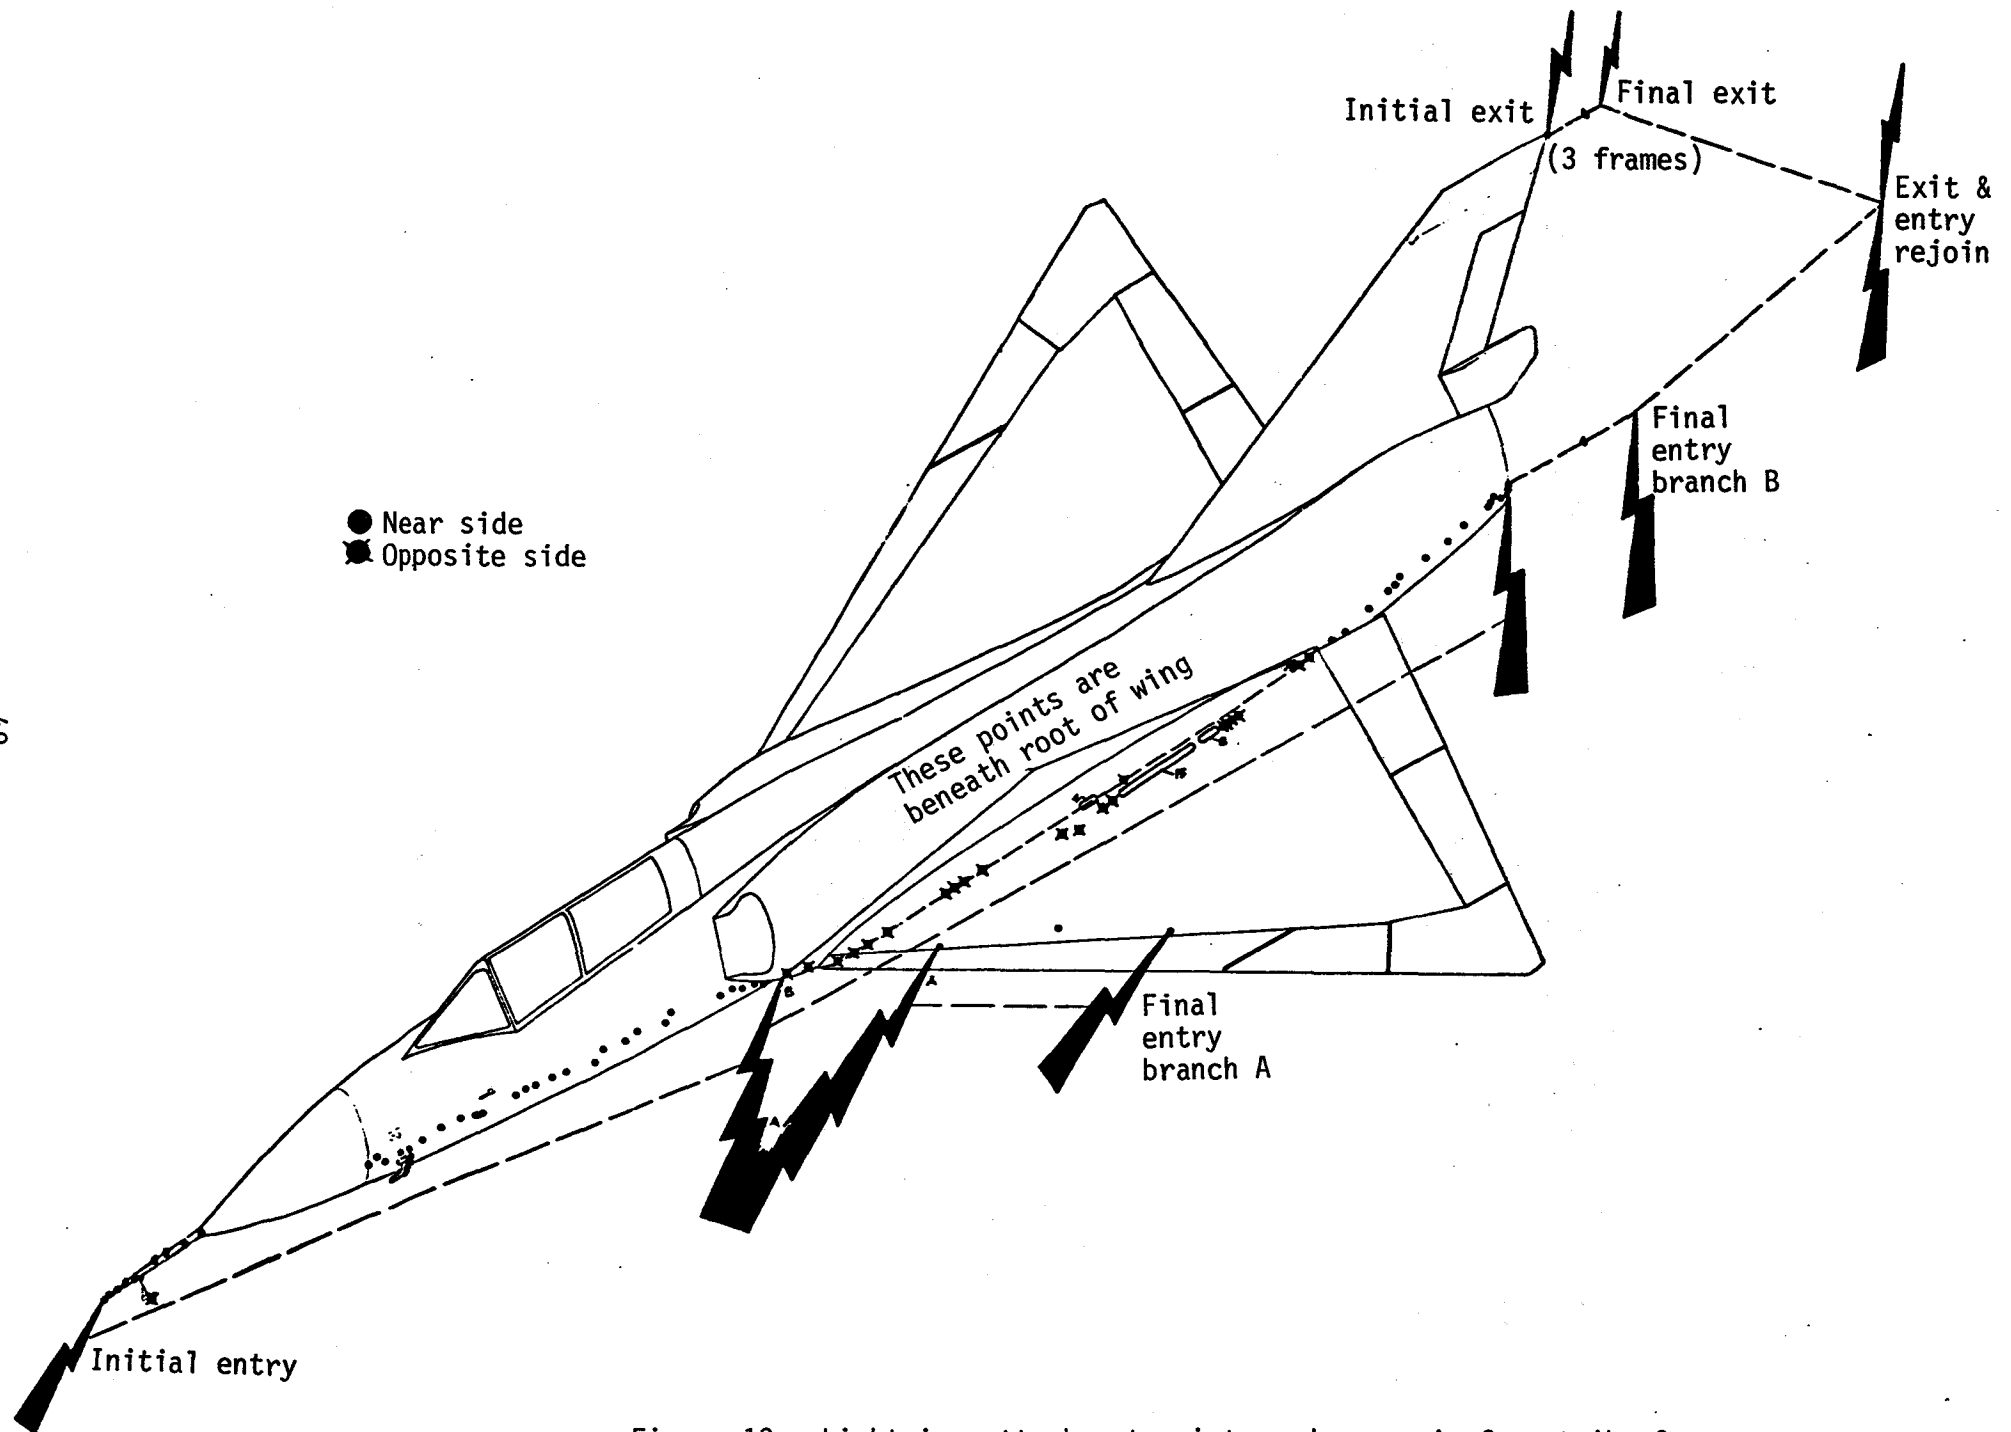
Figure 13.- Lightning attachment points and scenario for strike 2, Flight 82-010.

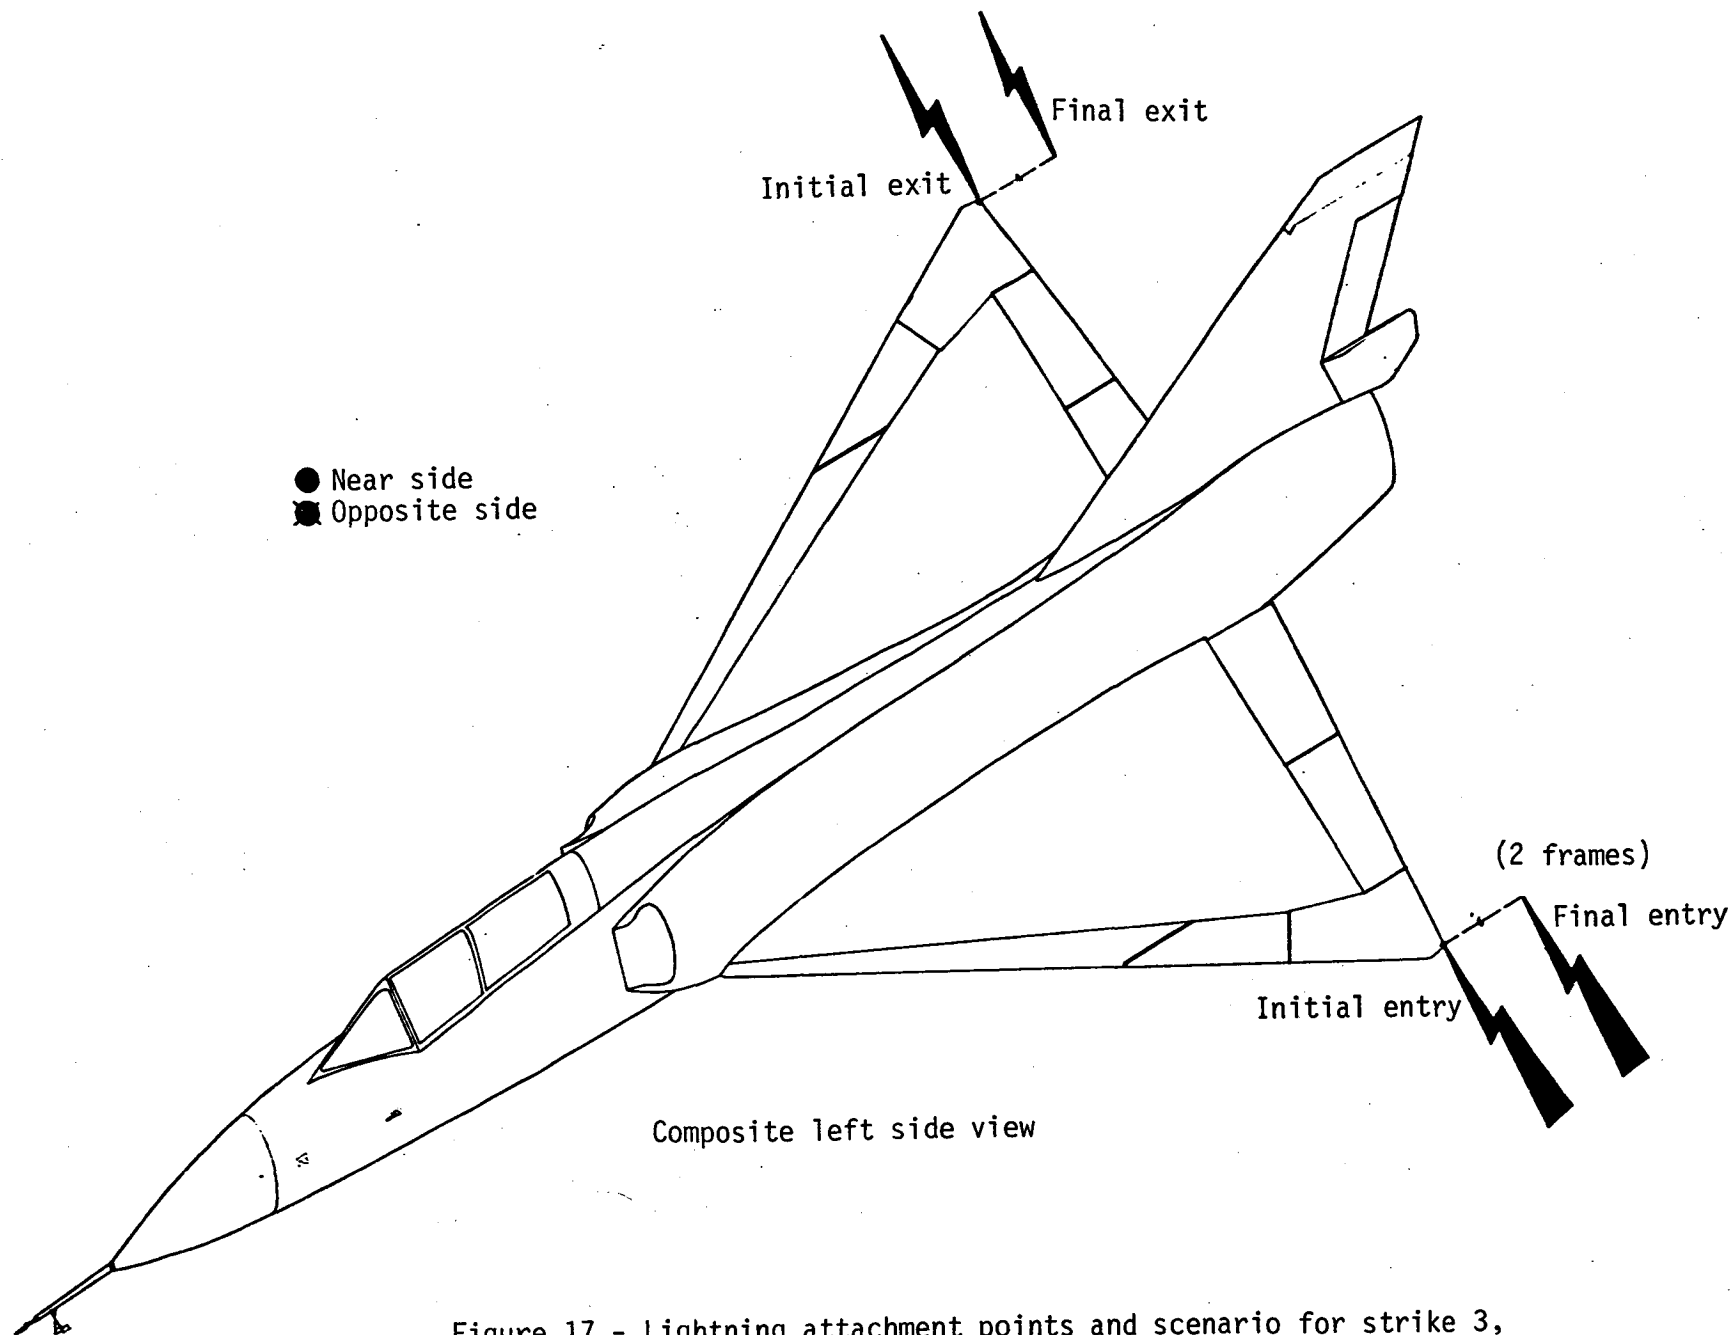
Figure 17.- Lightning attachment points and scenario for strike 3, Flight 82-010.

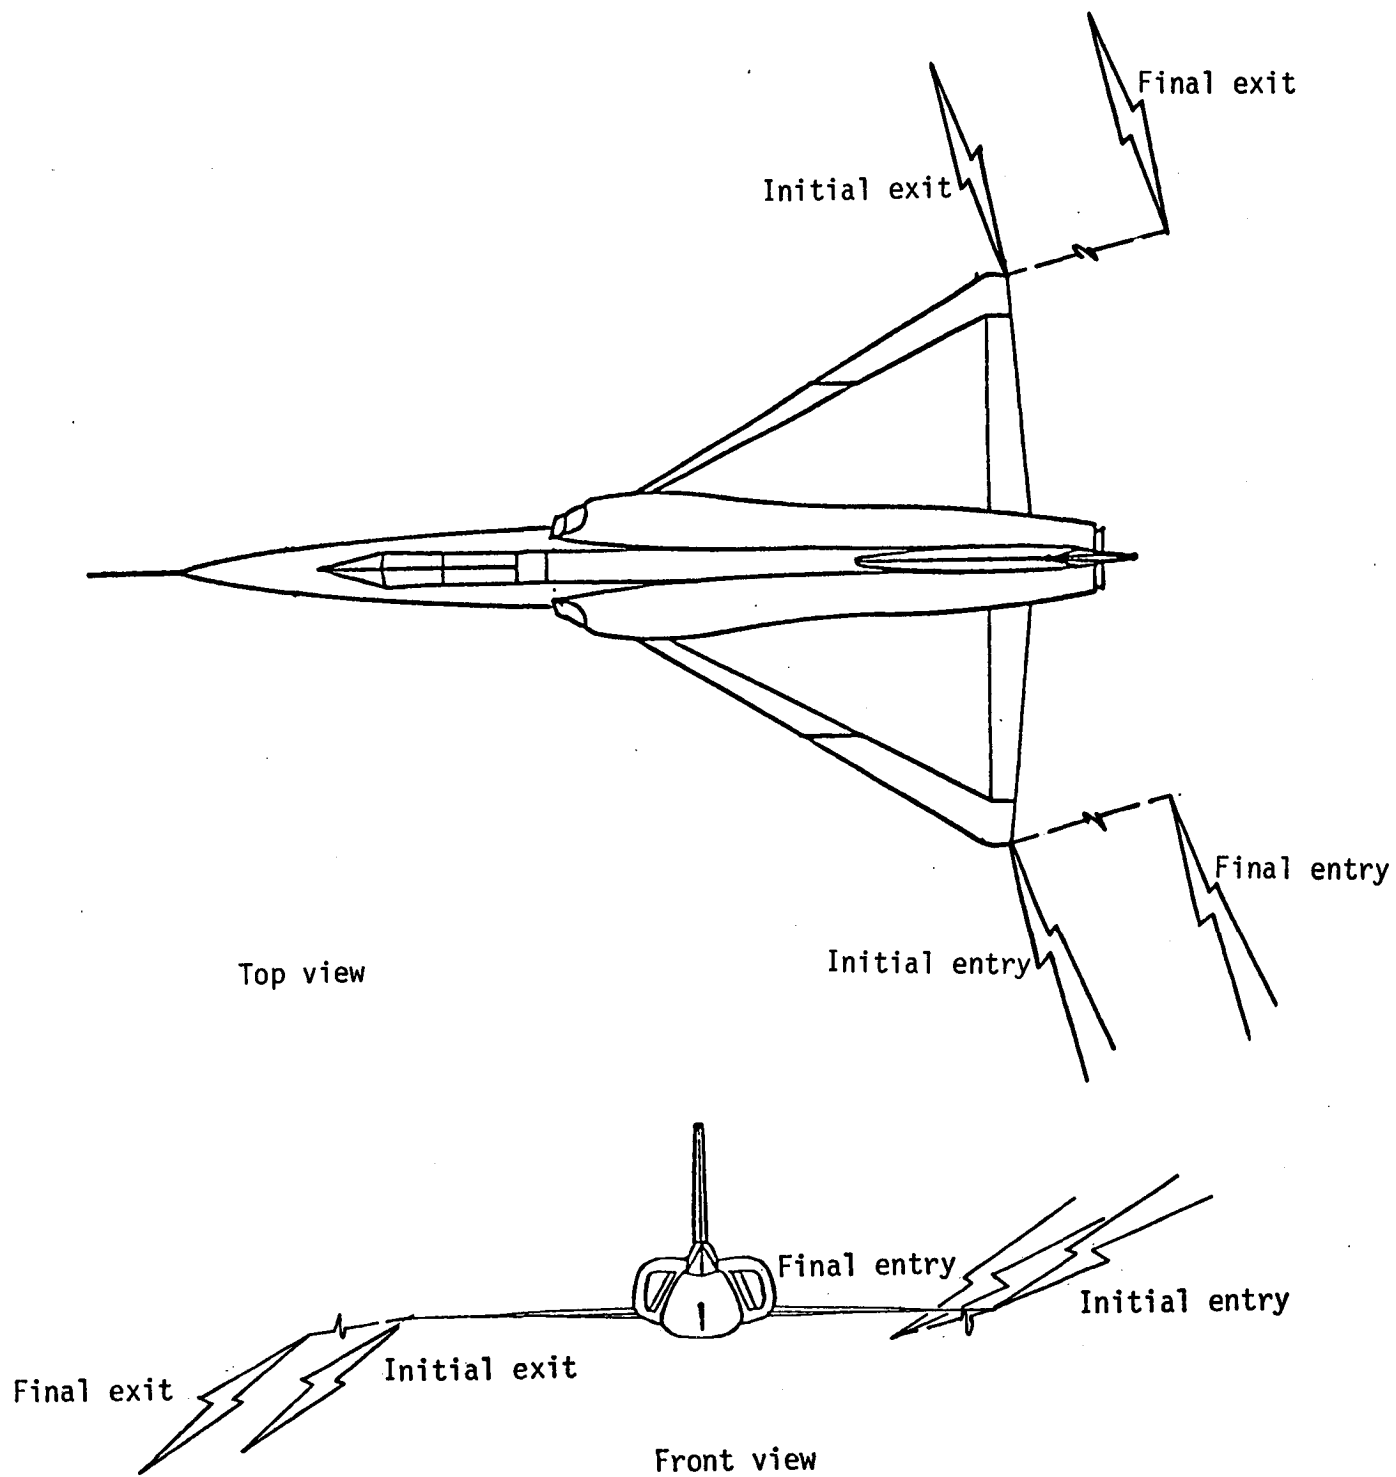
Figure 18.- Lightning attachment point scenario for strike 3, Flight 82-010.

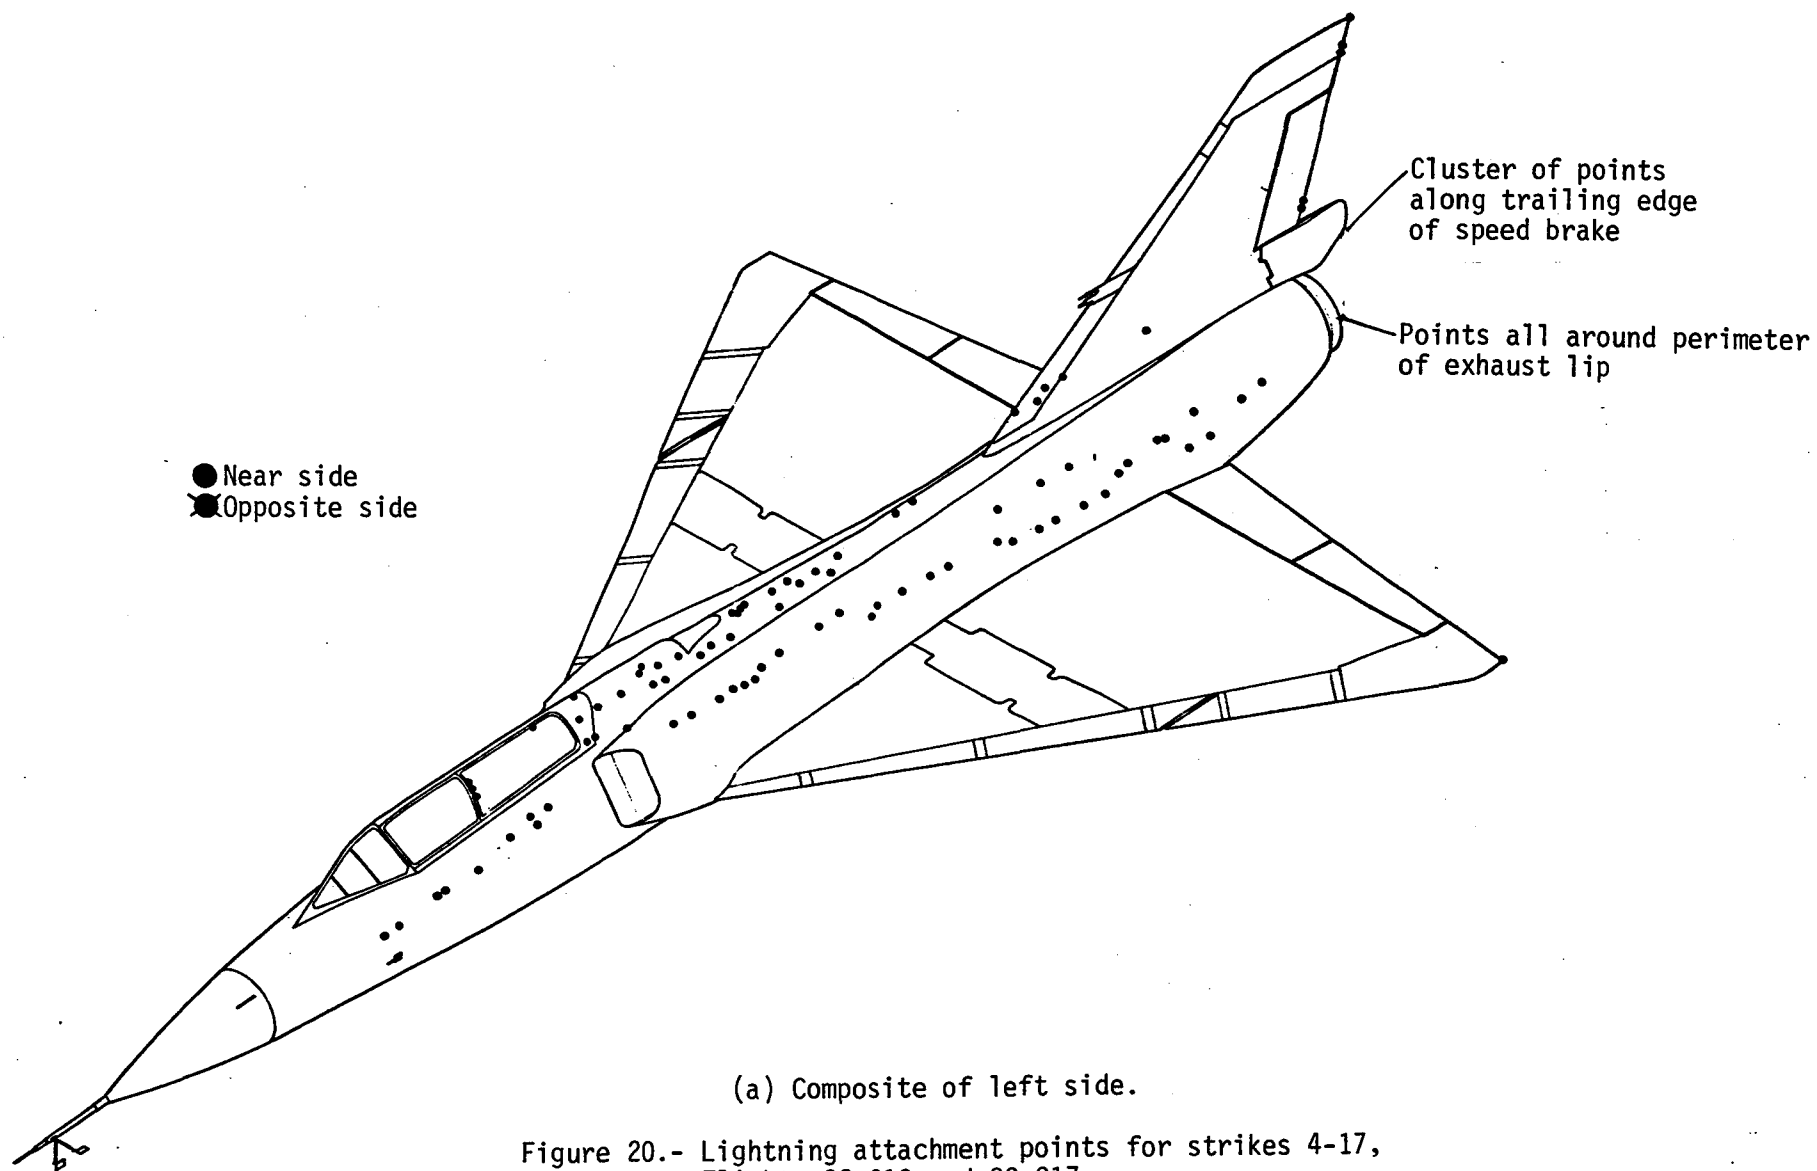
4. Strikes in which the initial and final entry and exit points are confined to the aft extremities, as shown in figures 20, 45, 46, and 47 (strike 15 of 1982). About one-third of the strikes to date have demonstrated this pattern.

Cluster of points along
trailing edge of speed brake

Points all around perimeter
of exhaust lip

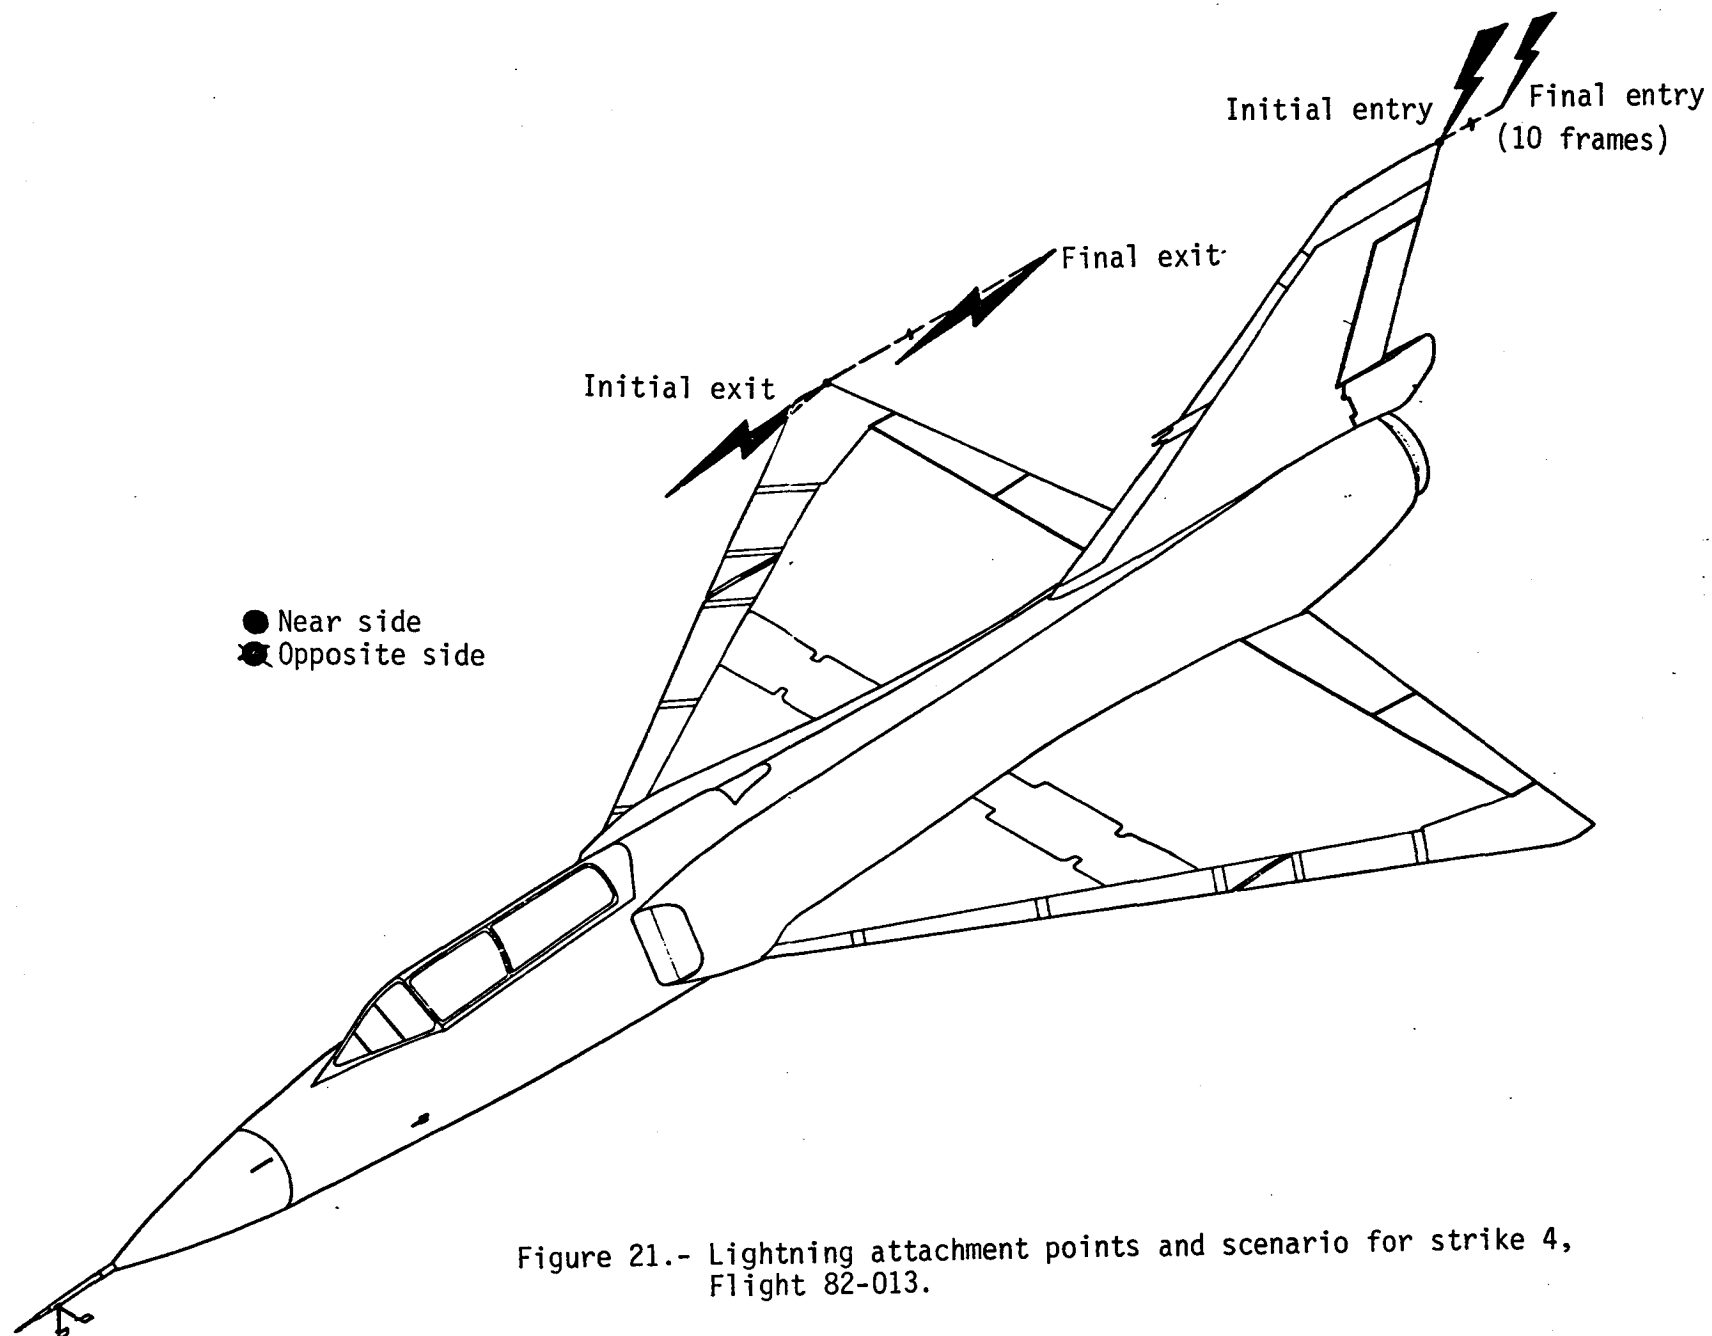
Figure 21.- Lightning attachment points and scenario for strike 4, Flight 82-013.

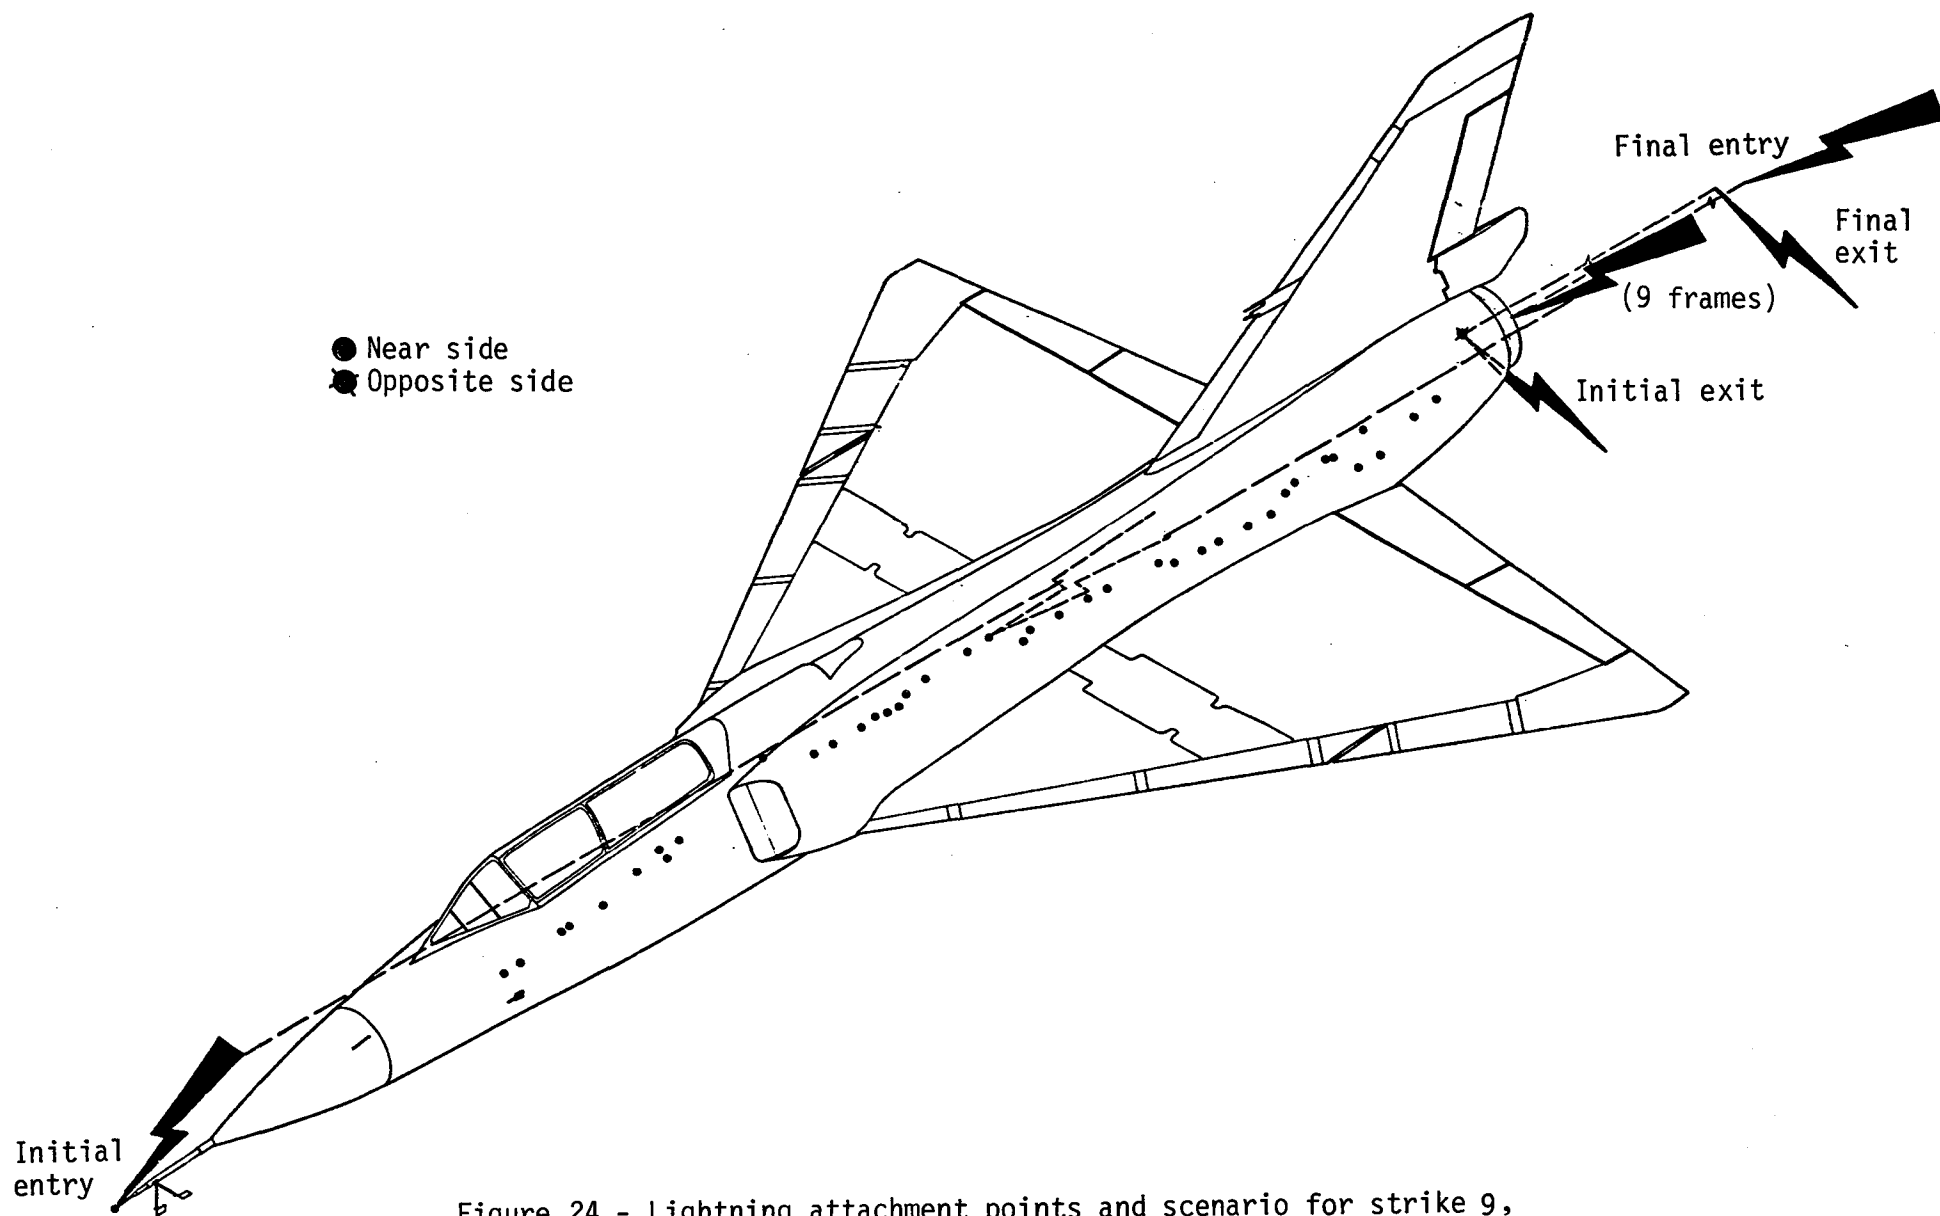
Figure 24.- Lightning attachment points and scenario for strike 9, Flight 82-017.

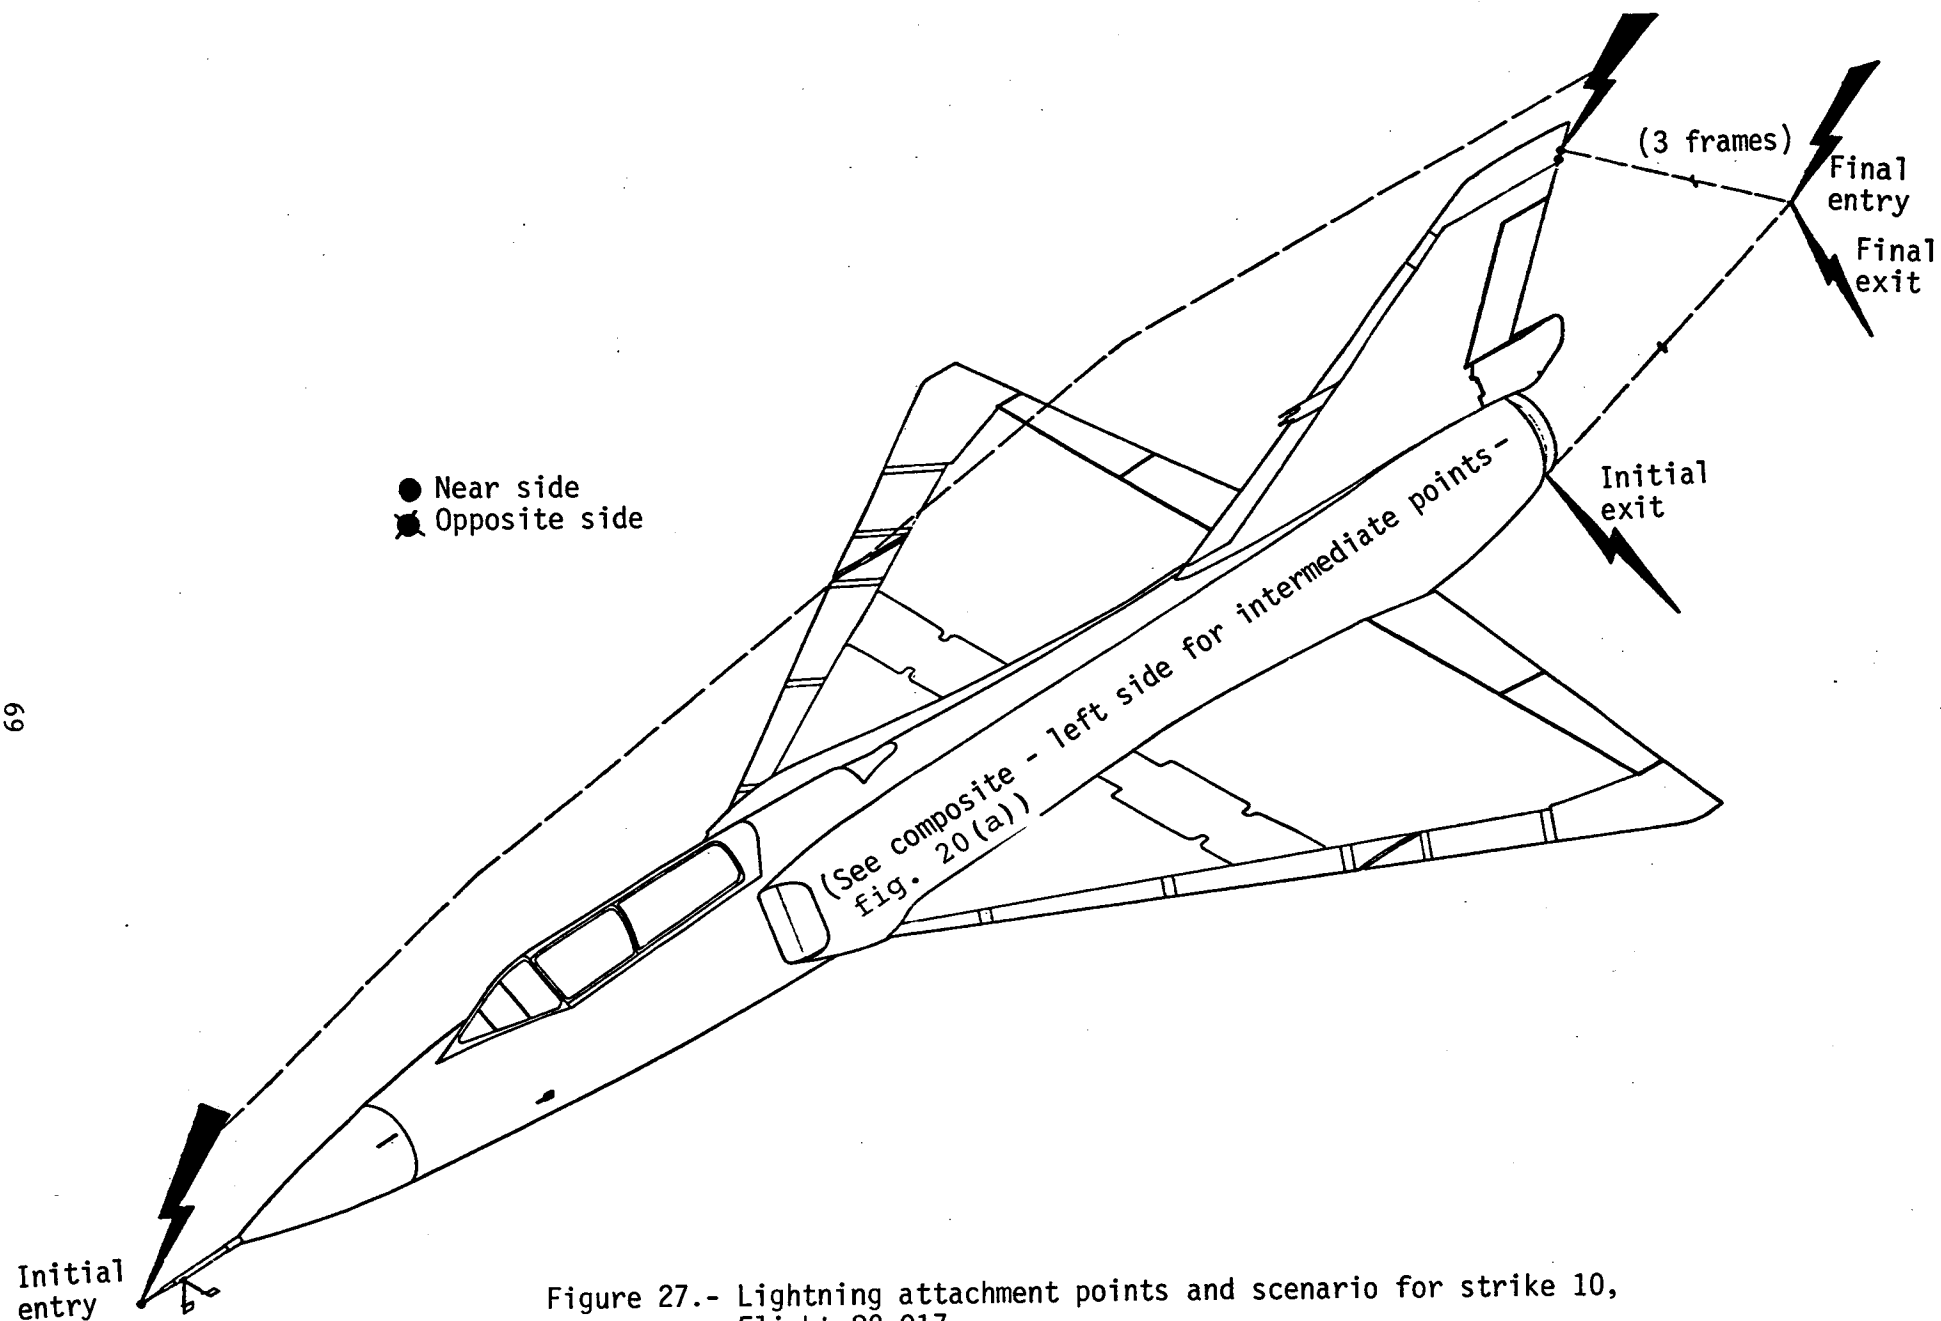
Figure 27.- Lightning attachment points and scenario for strike 10, Flight 82-017.

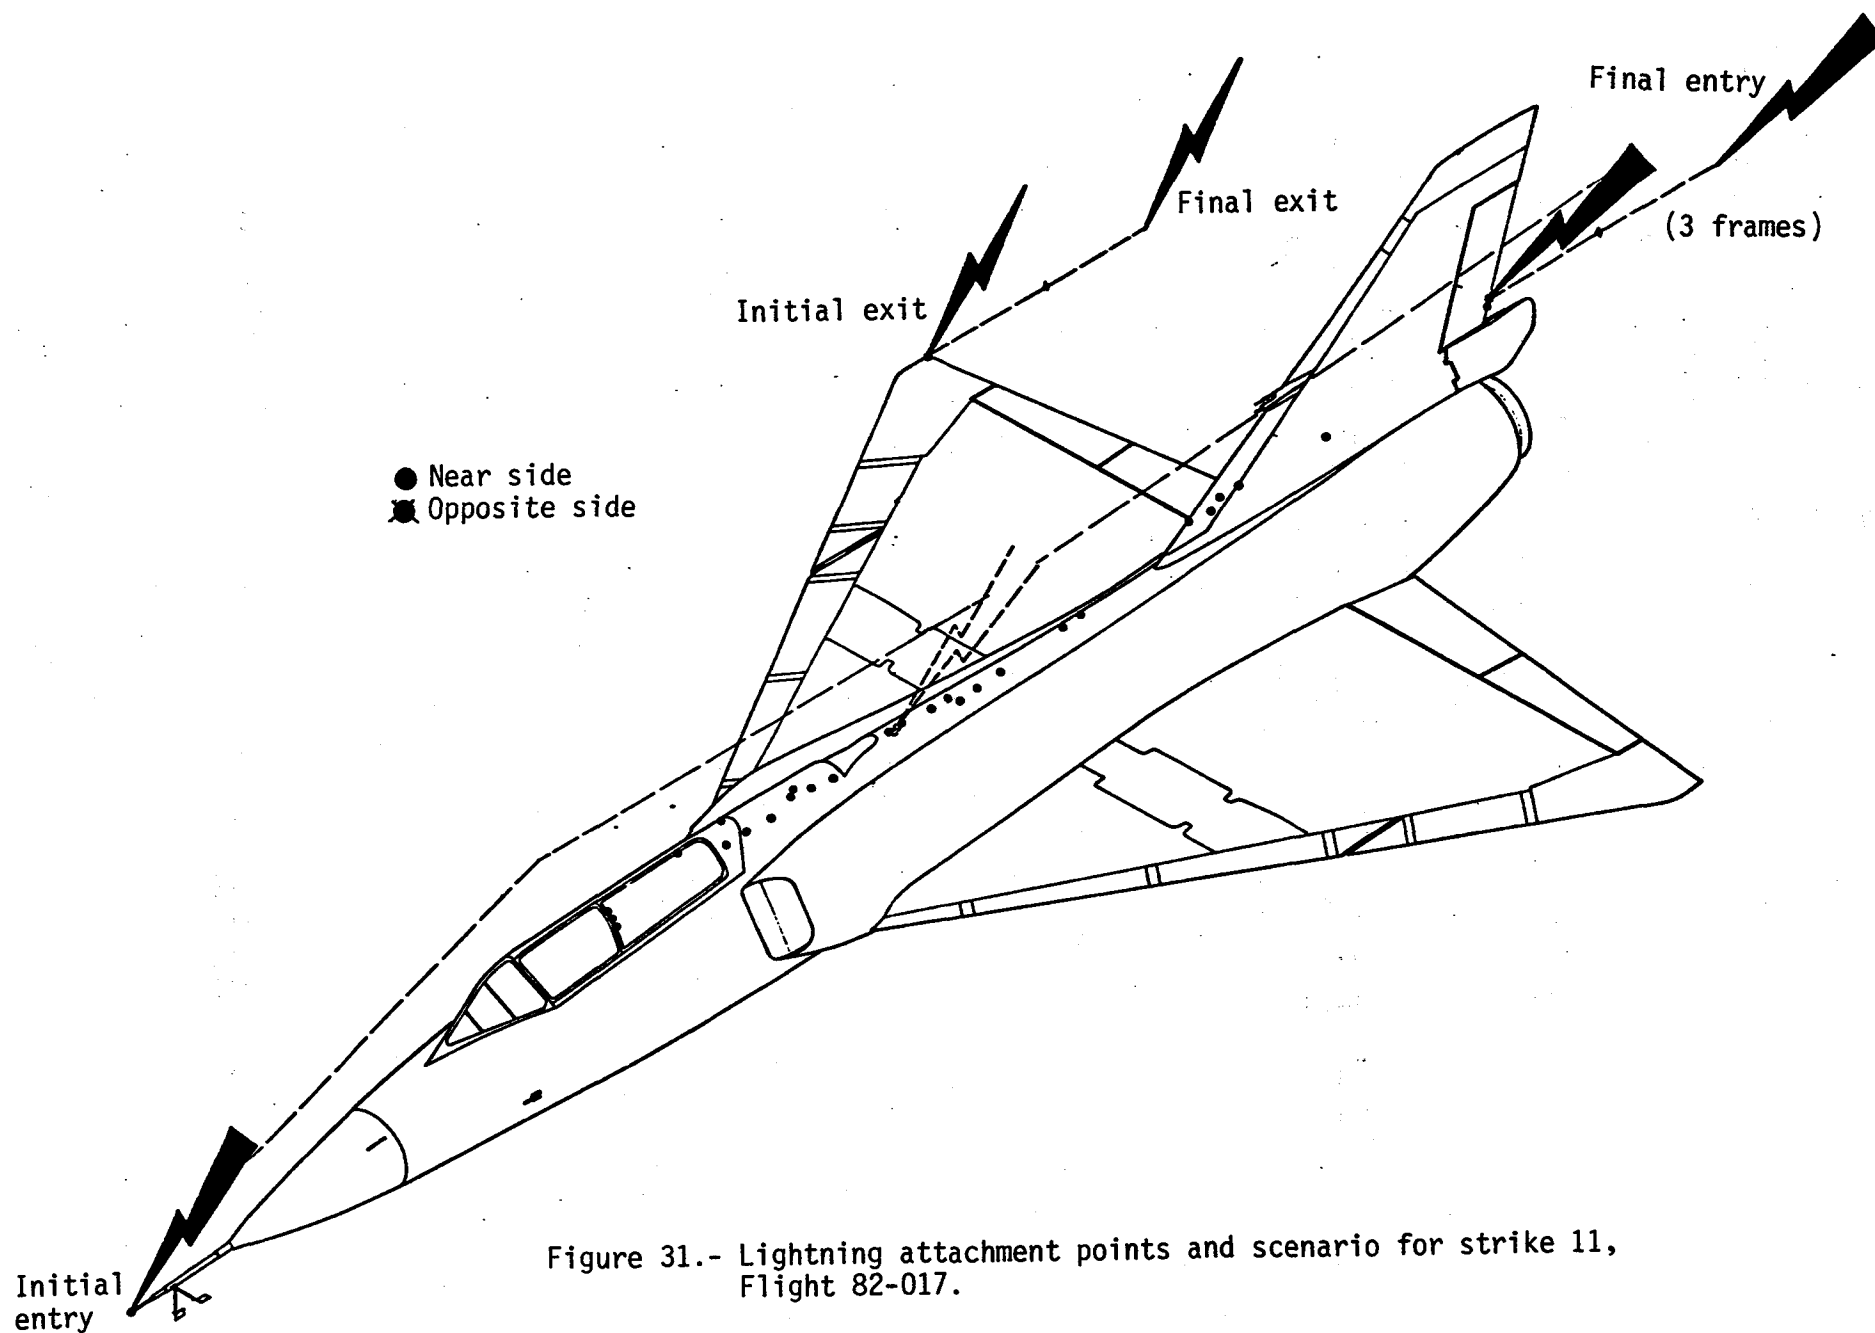
Figure 31.- Lightning attachment points and scenario for strike 11, Flight 82-017.
